**DEPARTMENT OF TRANSPORTATION**

Contract #: 04-0120F4Cty: SF/ALA Rte: 80 PM: 13.2/13.9File #: 69.28**WELDING INSPECTION REPORT****Resident Engineer:**Siegenthaler, Peter**Address:** 333 Burma Road**City:** Oakland, CA 94607**Report No:** WIR-024112**Date Inspected:** 29-May-2011**Project Name:** SAS Superstructure**OSM Arrival Time:** 1900**Prime Contractor:** American Bridge/Fluor Enterprises, a JV**OSM Departure Time:** 700**Contractor:** Zhenhua Port Machinery Company, Ltd (ZPMC), Changxing Island **Location:** Shanghai, China**CWI Name:** See Below**CWI Present:** Yes No**Inspected CWI report:** Yes No N/A**Rod Oven in Use:** Yes No N/A**Electrode to specification:** Yes No N/A**Weld Procedures Followed:** Yes No N/A**Qualified Welders:** Yes No N/A**Verified Joint Fit-up:** Yes No N/A**Approved Drawings:** Yes No N/A**Approved WPS:** Yes No N/A**Delayed / Cancelled:** Yes No N/A**Bridge No:** 34-0006**Component:** OBG**Summary of Items Observed:**

**OBG Trial Assembly**

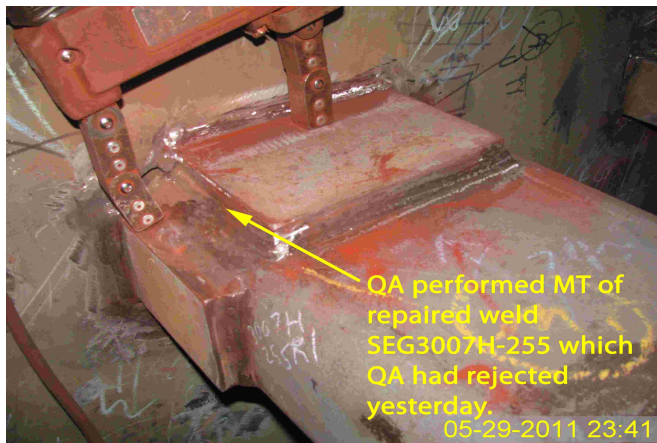
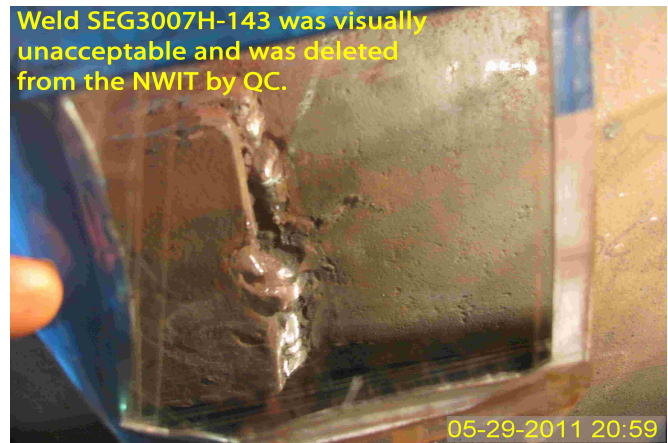
Item #1 also lists welds SEG3007H-128 and 129. This QA Inspector visually observed both of these welds were visually rejectable due to having unacceptable overlap, weld contour and slag. This QA Inspector observed weld SEG3007H-255 had a 5mm long linear magnetic particle indication approximately 65 mm from the end of the

weld. This QA Inspector informed ABF representative Mr. Kelvin Cheung and ZPMC QC Inspector Mr. Zhan Hai Feng that an incident report was being issued to document these visual and MT rejections. For additional information on these inspections see this QA Inspector's TL6028 Magnetic Particle Test Report. See the photographs below for additional information.
